### **Inspection of Refurbishment Works**

### **Street Properties in the Islington PFI 1 Contract**

REPORT 2

**Consul ref: 556/04/PFI**

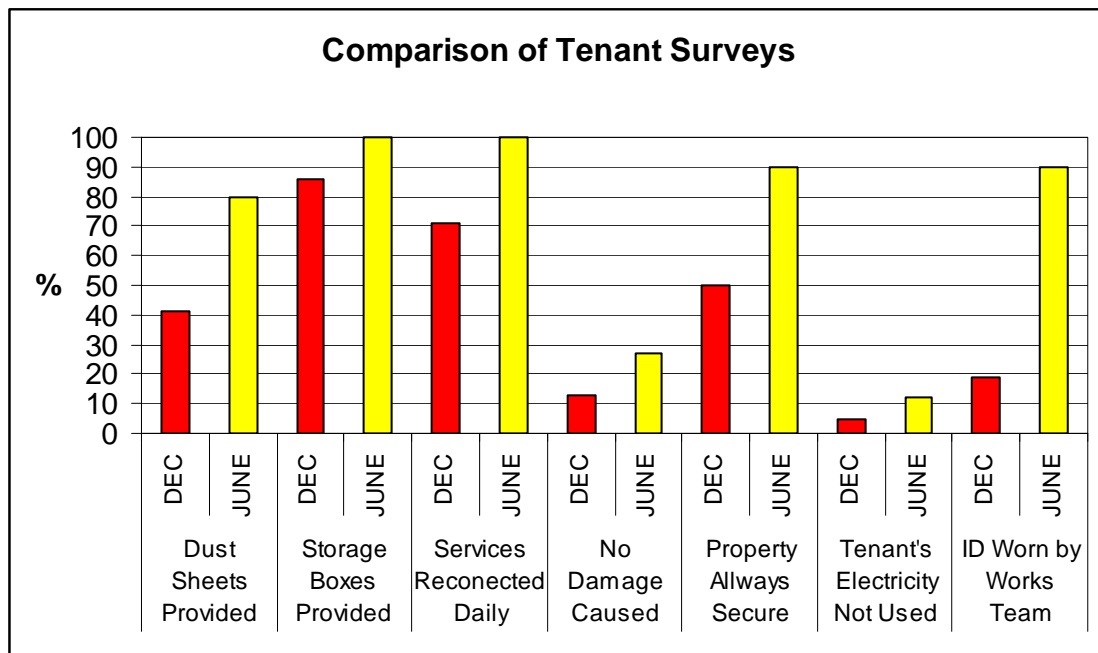
The chart below compares the results of tenant surveys done for this report and the first report by Consul published in January 2005.

The chart clearly demonstrates an improvement in tenants' experiences of the works since the implementation of United House's Action Plan in January 2005.
